EVERY DROP COUNTS

A First Assessment of Restoration Impact on Soil Moisture and Water Balance in Jordan's Rangelands

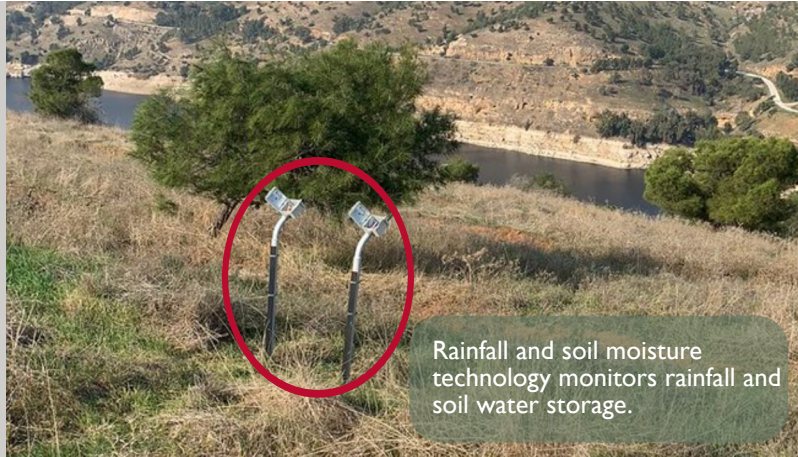
Rainfall and soil moisture technology monitors rainfall and soil water storage.

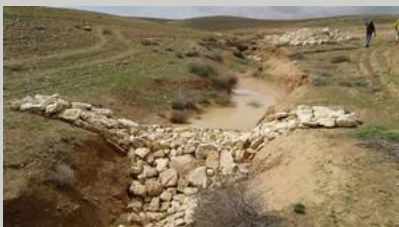
A gully plug post rainfall, outside Amman, Jordan. Source: Stefan Strohmeier

Gully restoration focuses on treating gullies and channels with community-implemented gully plugs that reduce flow velocity and dissipate the erosive energy of the water. The practice fosters local sedimentation, increased infiltration, and reduced evaporation.

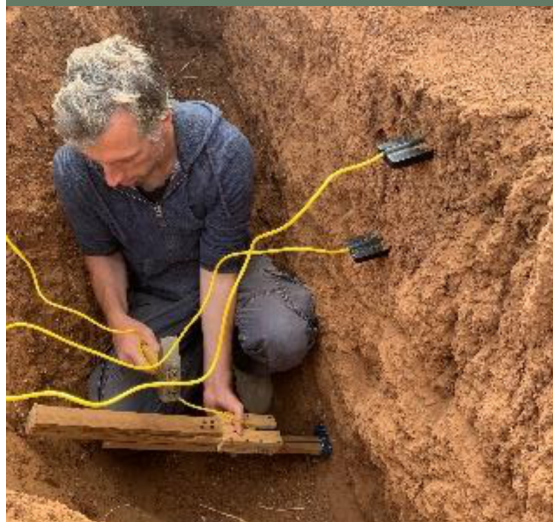
Above, ICARDA scientist Stefan Martin Strohmeier attaches sensors for measuring soil water storage. The sensors indicated by red circles in the restoration diagram below.

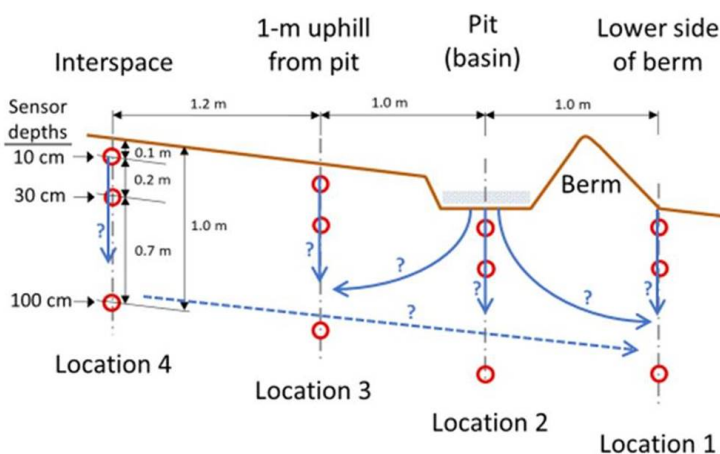
The diagram above and charted results below illustrate water infiltration results at the Royal Botanical Gardens restoration site, outside Amman, Jordan.

The diagram to the left illustrates how restoration partners are measuring their water infiltration effectiveness. The results from the sensors (red circles) are plotted below. The green line on the bottom left chart shows that water has successfully infiltrated at the greatest sensor depth within the pit (location 2). The chart on the bottom right shows continued water infiltration downslope of the berm (location 1).
